# BUILDING & PEST INSPECTION

**123 Demo Drive, Demoville, NSW, 2000**

**INSPECTED 4TH OCTOBER 2020**

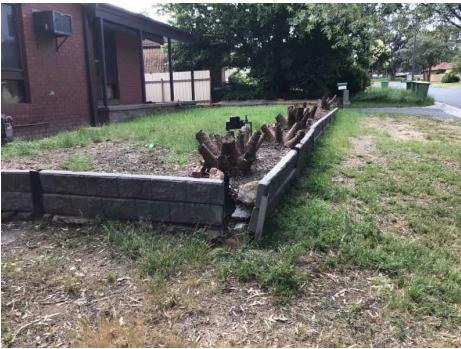
#2.17 - Retaining Walls

Perimeter Fences	Steel		
Dividing Fences	Steel		
Gates	Steel		
External Stairs	Brick, Timber		
Hand Rails	Timber		
Retaining Walls (Non-Structural)	Timber, Concrete		
Driveways	Paving		
Paths	Concrete, Paving		
Back Fence		OK	
Left Side Fence		OK	
Right Side Fence		Maintenance Required	
Dividing Fence		OK	
Gates		OK	
Driveway Pavement		Photo: # 2.13	Repairs Required
The driveway pavement needs to be repaired			
Paths Pavement		Photo: # 2.14	Repairs Required
The pavement around the perimeter of the building will need to be repaired at some stage			
External Stairs			Maintenance Required
External Handrails		Photo: # 2.16	Maintenance Required
Retaining Walls		Photo: # 2.17	Repairs Required
The retaining walls will need to be repaired at some stage

*The retaining walls will need to be repaired at some stage*

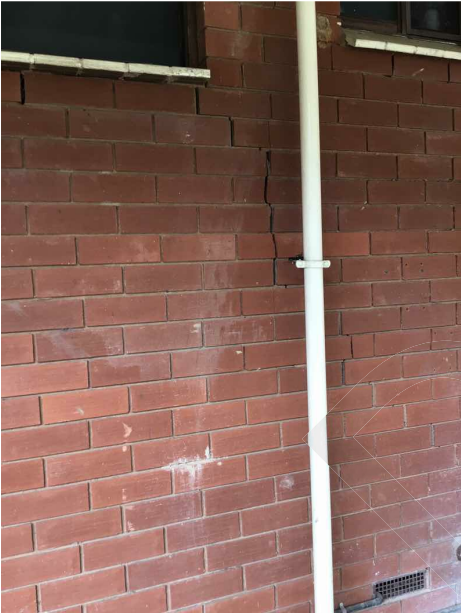
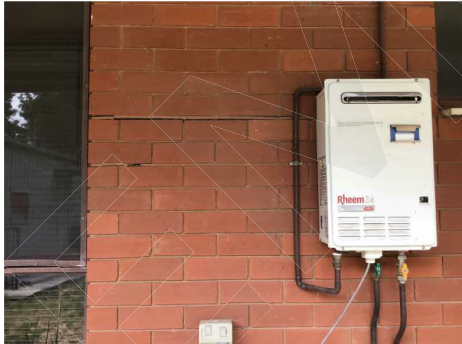
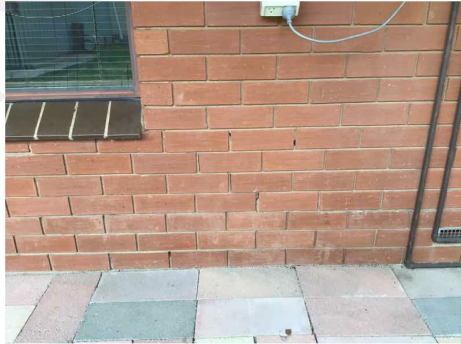
<p>#9.1 - Cracks In Brickwork</p>

Visible Evidence of Makeover	No
<b>Cracks In Brickwork</b>	Photo: # 9.1 <span>OK</span>
<i>There is wall crack in the external brickwork these are movement crack . This is caused by the reactive soil in this area . In the summer the ground it's like concrete and in winter it's like mud . It looks like the building has settled over the years. And now only the be repaired</i>	
<b>Gaps Around Windows</b>	Photo: # 9.2 <span>OK</span>
<i>As above</i>	
<b>Internal Wall Linings</b>	<span>OK</span>
<b>External Wall Linings</b>	<span>Repairs Required</span>
<b>Internal Wall Structure</b>	<span>OK</span>
<b>External Wall Structure</b>	<span>Repairs Required</span>
<b>Dampness In Internal Walls</b>	<span>OK</span>
<b>Dampness In External Walls</b>	<span>OK</span>
<b>Dampness In Ceiling</b>	<span>OK</span>
<b>Dampness In Roof</b>	<span>OK</span>
<b>Internal Wall Movement</b>	<span>OK</span>
<b>External Wall Movement</b>	Photo: # 9.12 <span>OK</span>
